Letter of the test results - fire resistance tests on hinged folding steel doors

Fire resistance test on July 2, 2015 – door with its railing mounted on the exposed side of the supporting construction

Fire resistance test on August 21, 2015 – door with its railing mounted on the unexposed side of the supporting construction

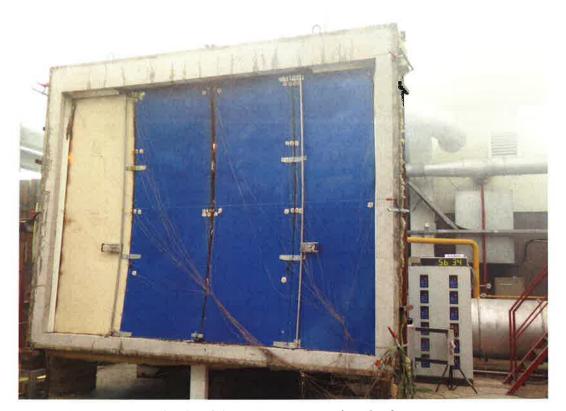
The test was terminated 55 min after the start of the test. The test specimen met criteria for integrity (E) for 43 minutes and for insulation (I₁) for 32 minutes and for insulation (I₂) 33 minutes.

Figure 3. Unexposed side of the test specimen after the fire test.

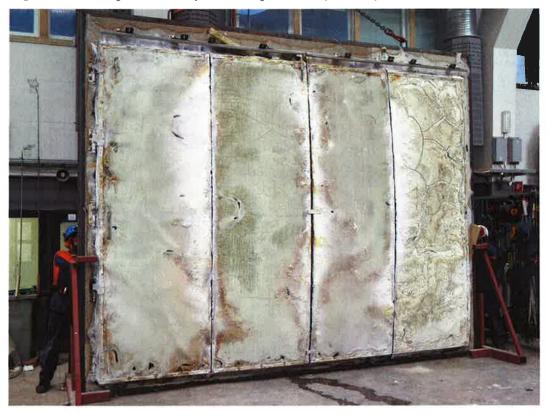
Figure 4. Exposed side of the test specimen after the fire test.

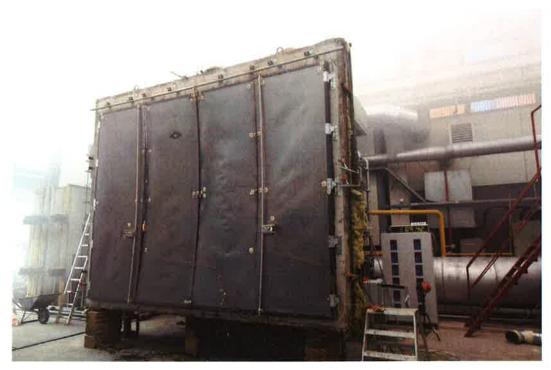
The test was terminated 69 min and 10 s after the start of the test. The test specimen met criteria for integrity (E) for 68 minutes and for insulation (I_1) for 39 minutes and for insulation (I_2) 51 minutes.

Figure 3. Unexposed side of the test specimen after the fire test.

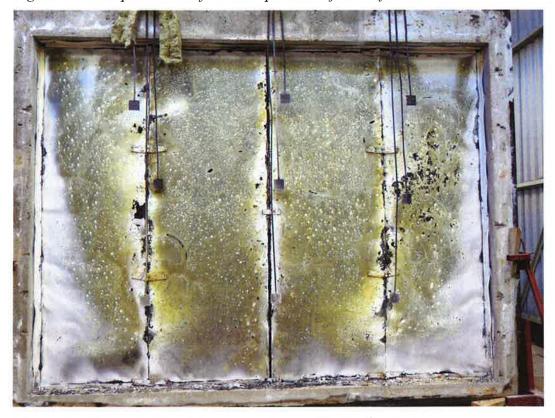
Figure 4. Exposed side of the test specimen after the fire test.
